NAVAL AIR WARFARE CENTER AIRCRAFT DIVISION  
PATUXENT RIVER, MARYLAND

REPORT NO: NAWCADPAX/TR-2013/252

### **COATED 4340 STEEL**

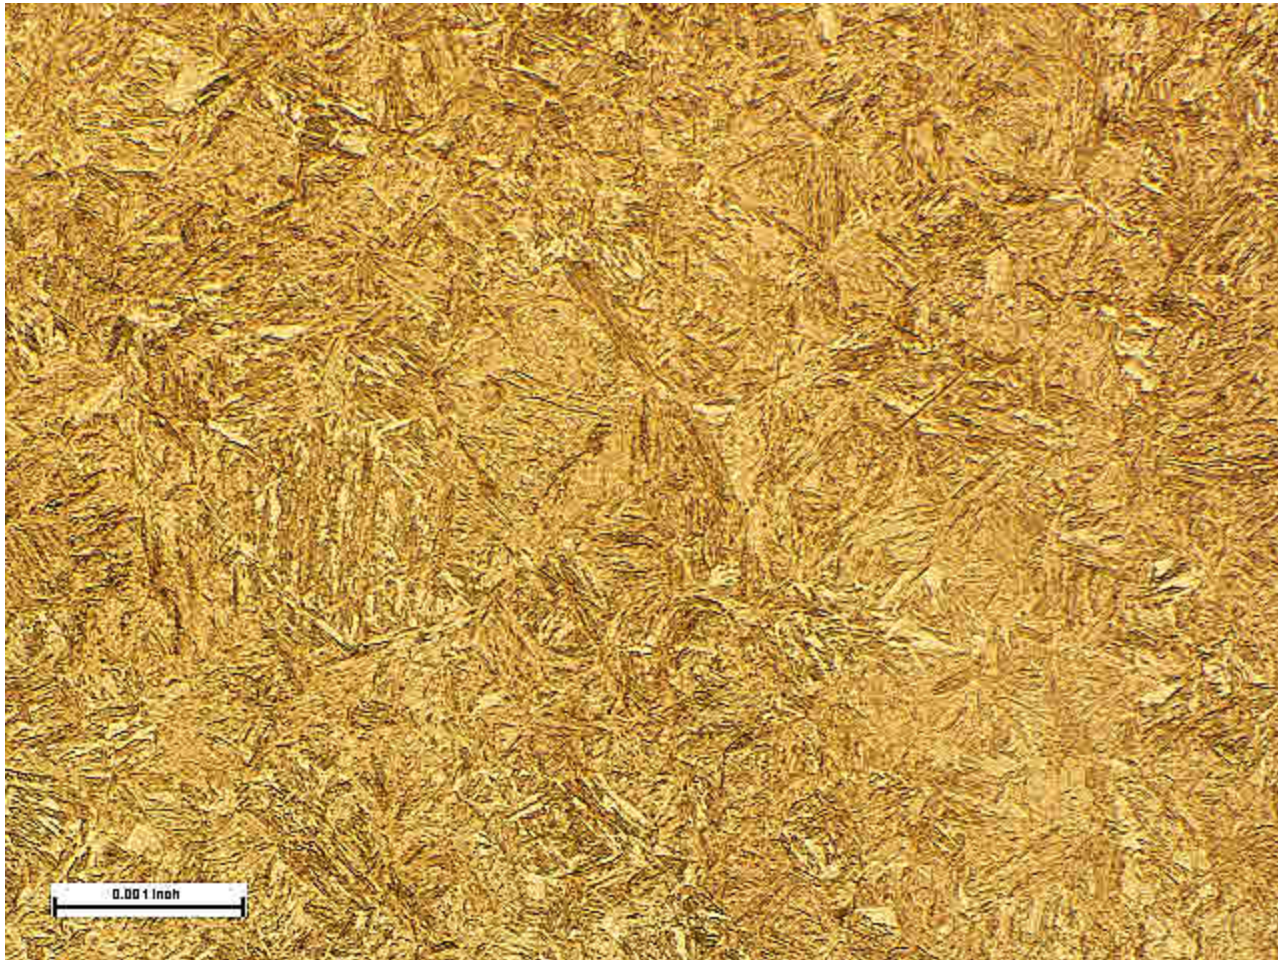
Figure 1: Microstructure of 4340 Steel

As the base or substrate material of the specimens, a 4340 steel plate of 2" x 6" x 12" was purchased from Metalmen Sales, Inc., New York, NY. Its chemical composition is shown in Table 1, and its microstructure in Figure A-1.

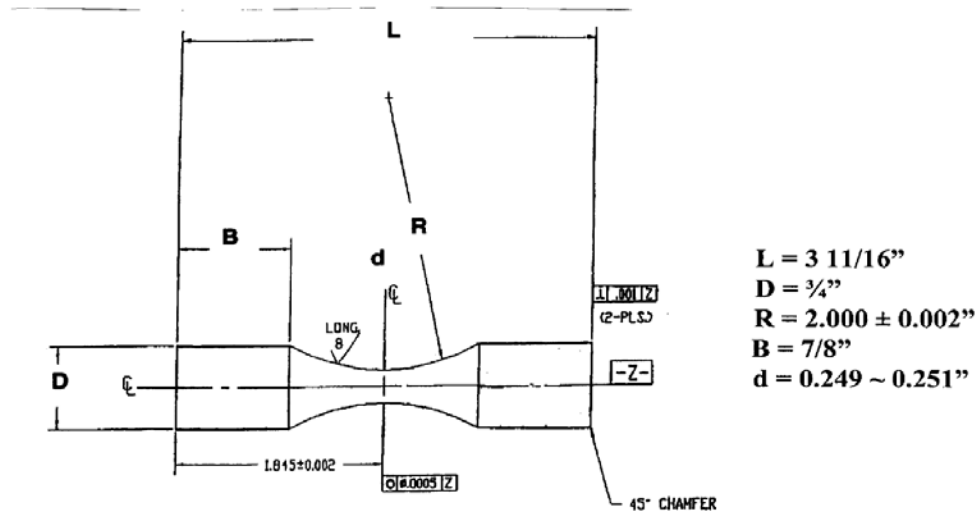
Figure 3. Round Hourglass Fatigue Test Specimen

The plate was machined to round tension test specimens in longitudinal (L-) orientation, Figure A-2, round hourglass fatigue test specimens in L-orientation, Figure A-3, and square bar SCC test specimens in L-T orientation, Figure A-4. The specimens of each type were divided into four groups, one for the test of bare specimens and the other three for the tests of plated or coated specimens.

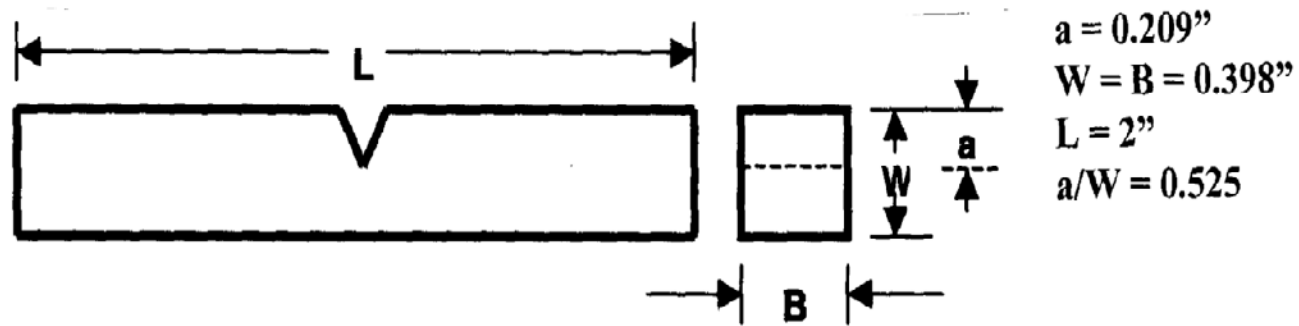
**Figure 4. Square Bar Stress Corrosion Cracking Test Specimen**

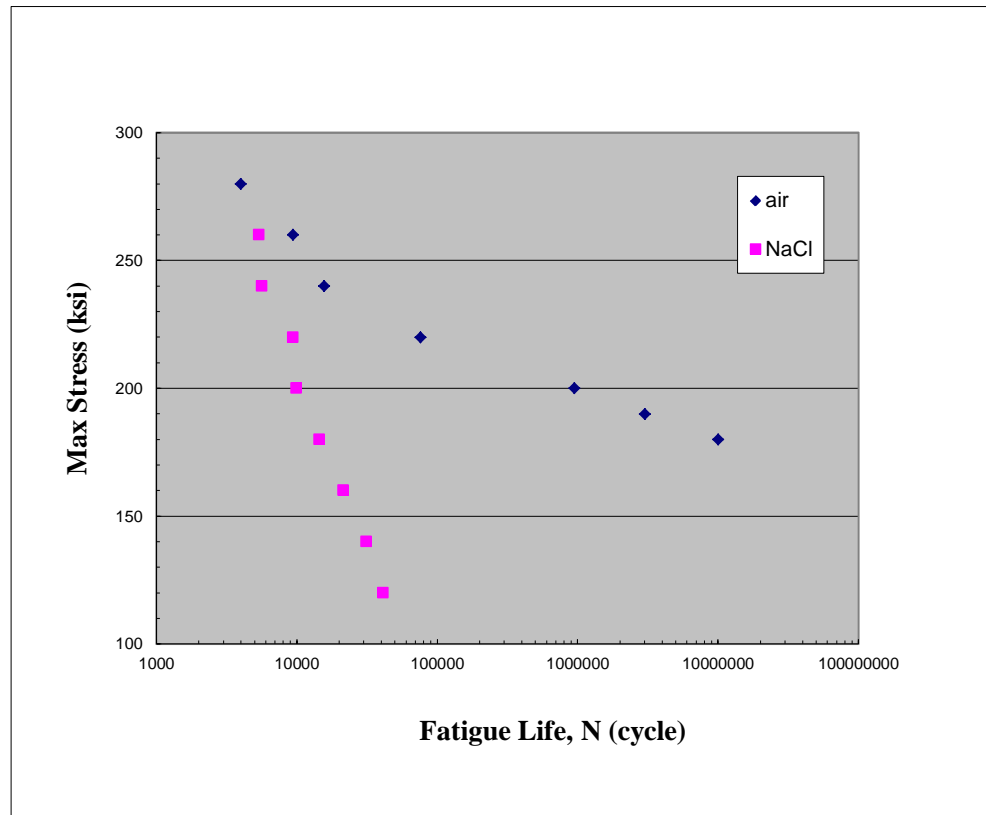
Figure 5: Stress-Life Fatigue Curves for Bare 4340 Steel

The stress-life (S-N) curves are shown for the bare and coated (Nos. 1, 2, and 3) specimens, fatigue-tested in air and 3.5% NaCl solution, in Figures A-5, A-6, A-7 and A-8, respectively. These figures compare the fatigue strengths in air and 3.5% NaCl solution for the respective coating systems. In all cases, the fatigue strength is lower and the life is shorter in 3.5% NaCl solution.

The fatigue strength and life are reduced in 3.5% NaCl solution, compared to those in air, for the bare and coated specimens, Figures A-5, A-6, and A-8. This observation indicates that those specimens, bare and coated, are susceptible to corrosion fatigue in 3.5% NaCl solution. However, the susceptibility to corrosion fatigue is less for those coated specimens than for the bare specimen, Figure A-10, indicating the protective role of the coatings against corrosion fatigue.

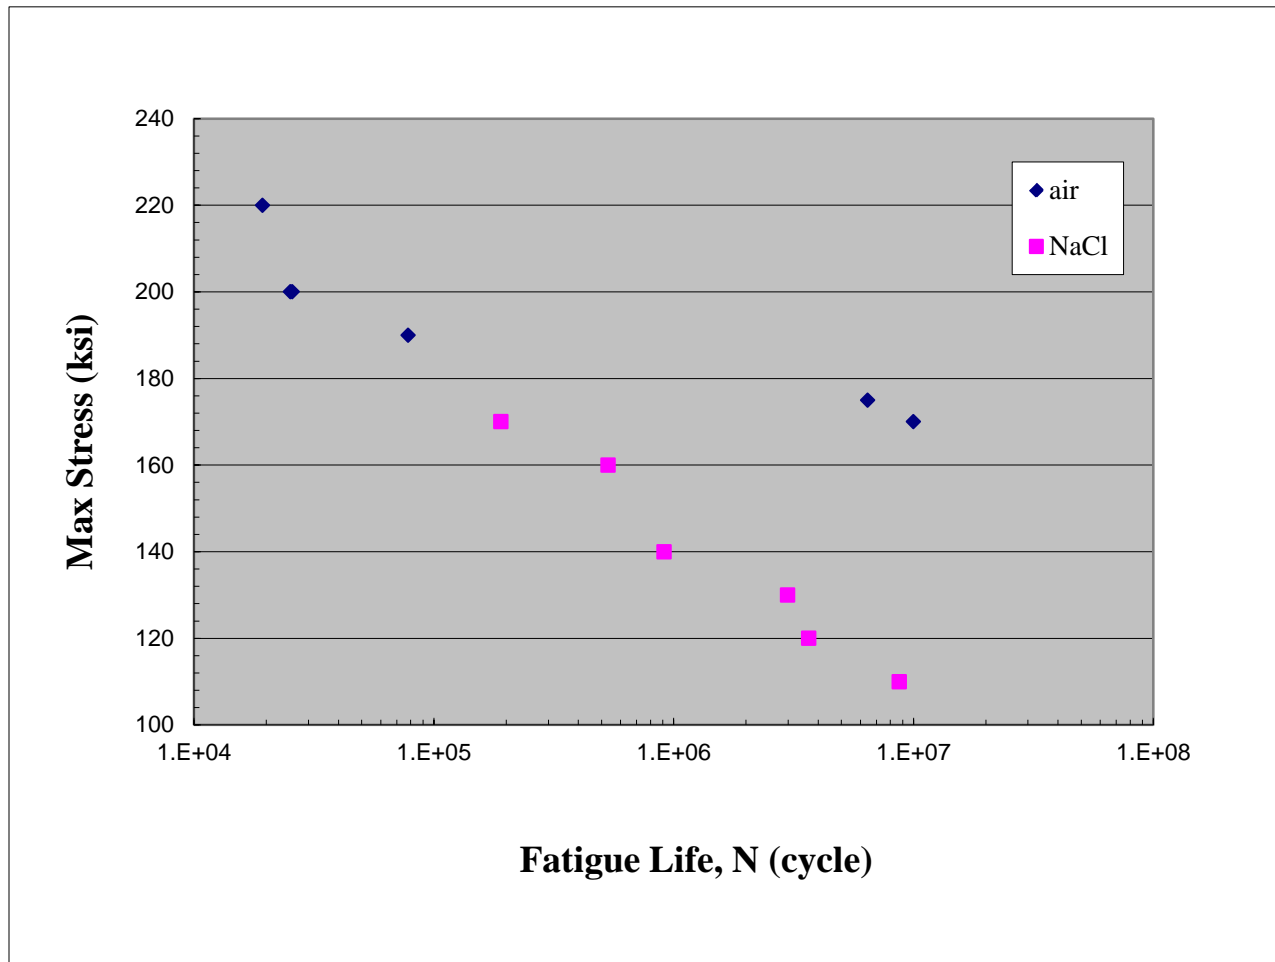
Figure 6: Stress-Life Fatigue Curves for No. 1 Surface-Treated 4340 Steel

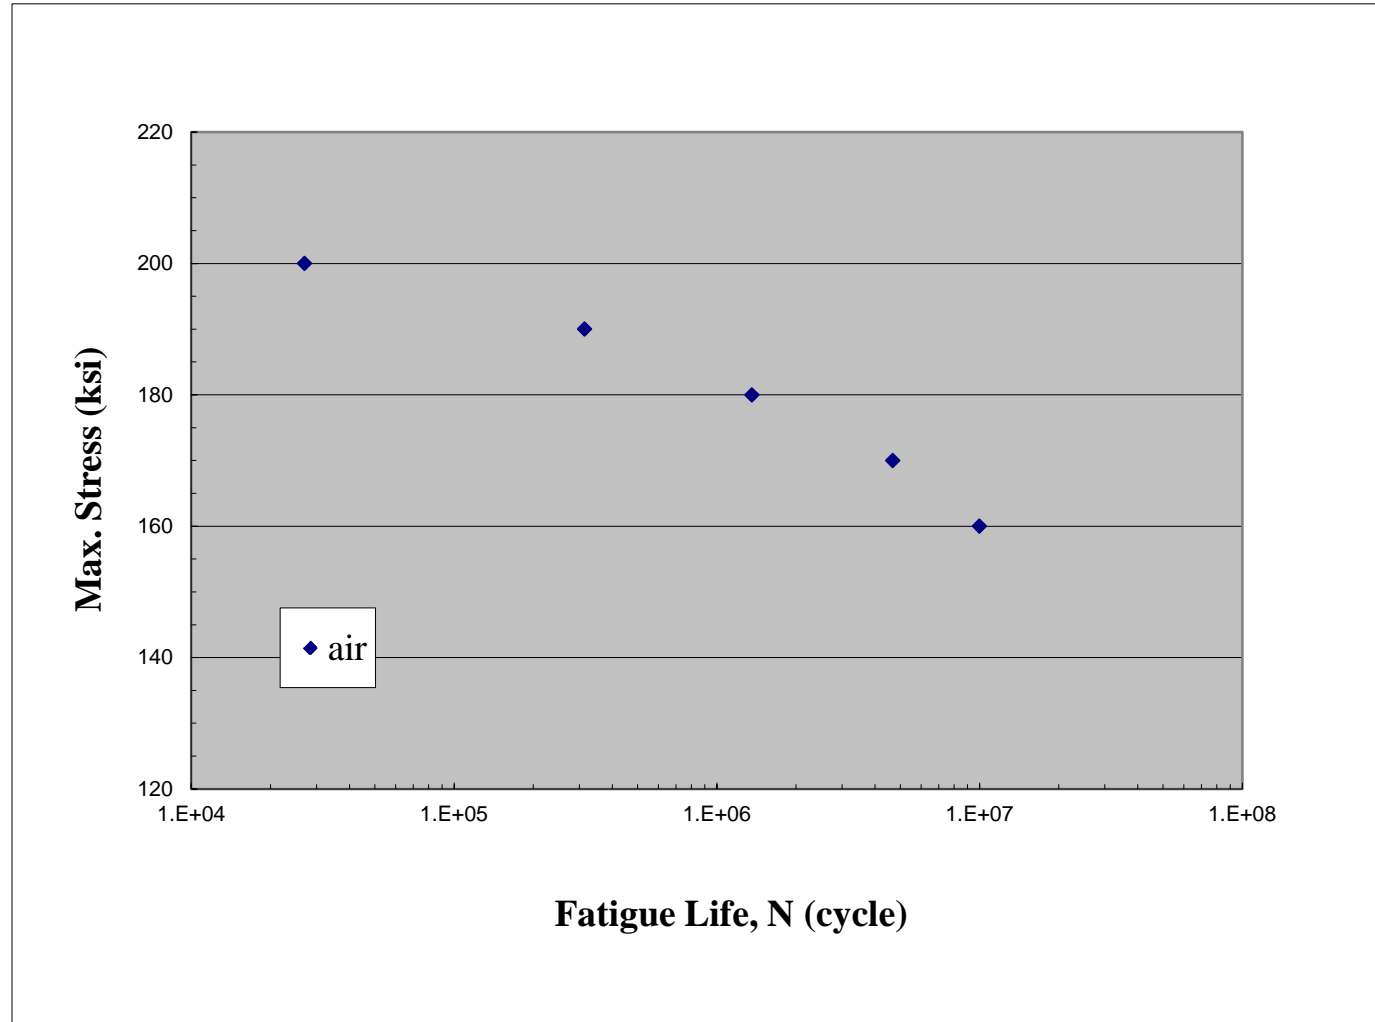
Figure 7: Stress-Life Fatigue Curve for No. 2 Surface-Treated 4340 Steel

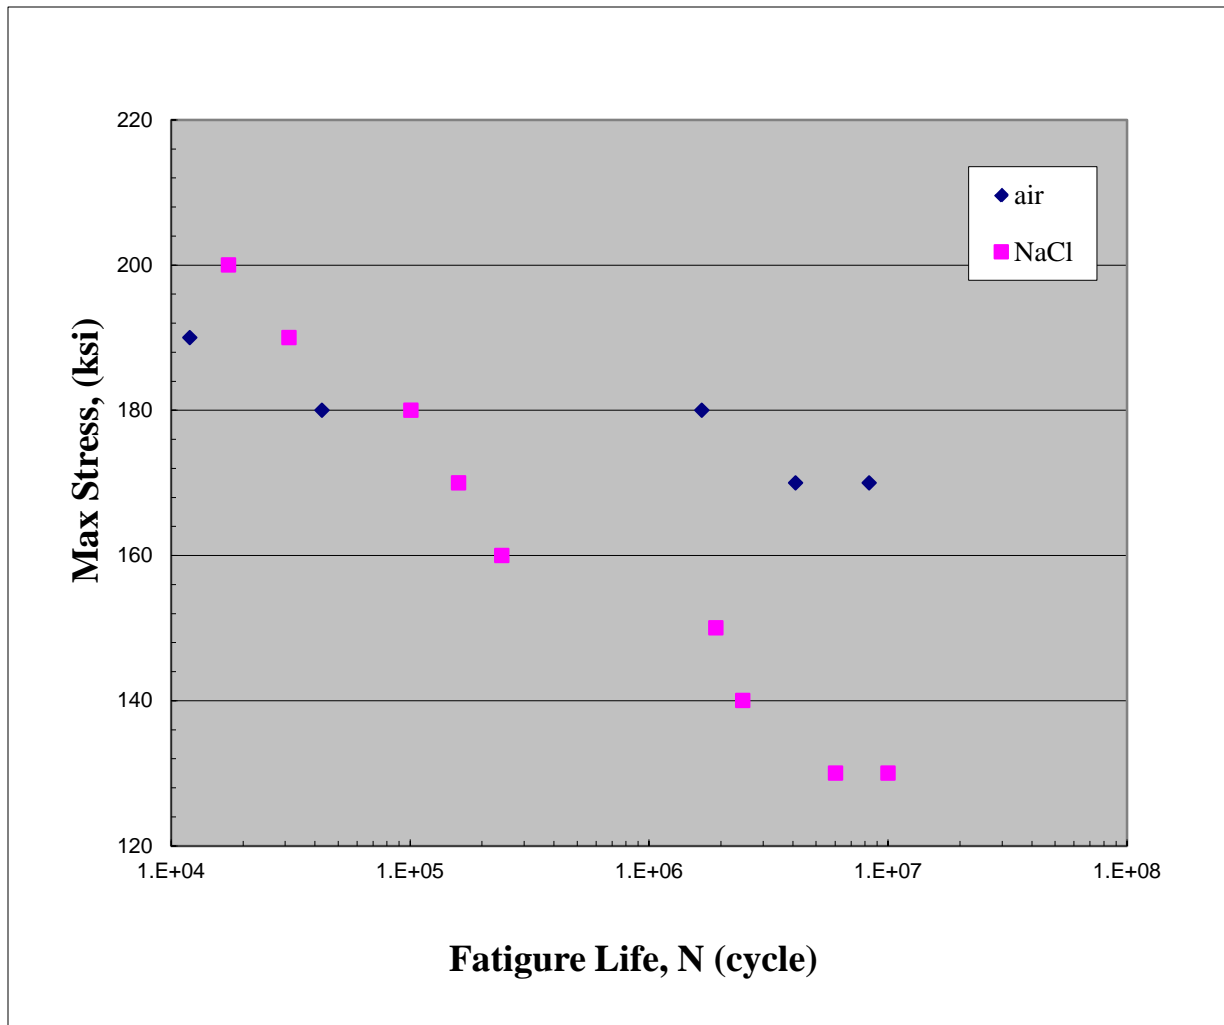
Figure 8: Stress-Life Fatigue Curves for No. 3 Surface-Treated 4340 Steel

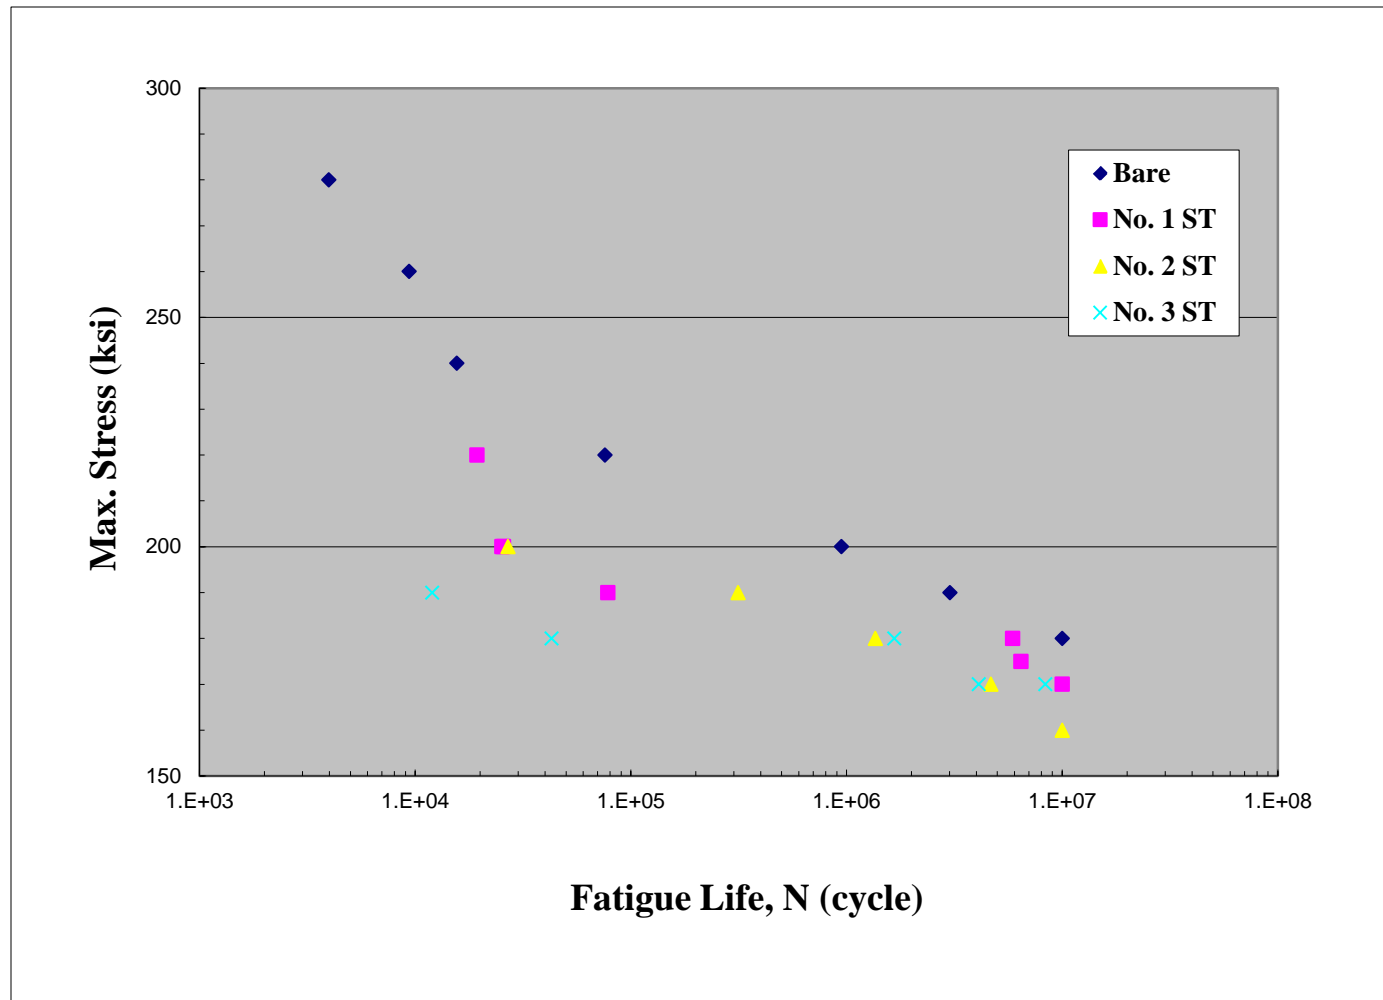
Figure 9: Stress-Life Fatigue Curves for Bare and Surface-Treated 4340 Steel Tested in Air

In order to compare the fatigue strengths of bare and coated specimens in air and 3.5% NaCl solution, their stress-life curves are plotted together in Figures A-9 and A-10, respectively. These figures show that

- The fatigue strength is greater for the bare specimen in air, but it is greater for the coated specimens in 3.5% NaCl solution.
- The stress-life curves for the coated specimens nearly overlap each other in both of the test environments, air and 3.5% NaCl solution.

The Nos. 1, 2, and 3 coating systems lower the fatigue strength and life in air compared to the bare specimen, Figure A-9. The SEM fractograph of No. 3 coating system specimen, fatigue-tested in air, shows scattered intergranularly separated smooth grain-facets and secondary cracks along grain boundaries, Figure A-13(a). Such a fractographic feature is typical of SCC (reference 18), hydrogen embrittlement (reference 19) and corrosion fatigue (reference 20). Since the fatigue test was conducted in air, the possibility of SCC and corrosion fatigue is very slim or none. Therefore, it is deducible that the reduction in fatigue strength and life is attributed to hydrogen embrittlement, induced during the process of the Cd-electroplating of the No. 3 coating system. The post-electroplating baking was said to have been done per LPS 430B (reference 21) and AMS-QQ-416 (reference 13). Accordingly, it is likely that the specifications are not quite adequate for the surface-treatment done or/and the post electroplating baking process was not carried out correctly. It remains to be clarified.

specimen, Figure 9. Therefore, it is deducible that the reduction in hardness is also attributed to the hydrogen embrittlement, induced during electroplating the cadmium, a part of each coating system.

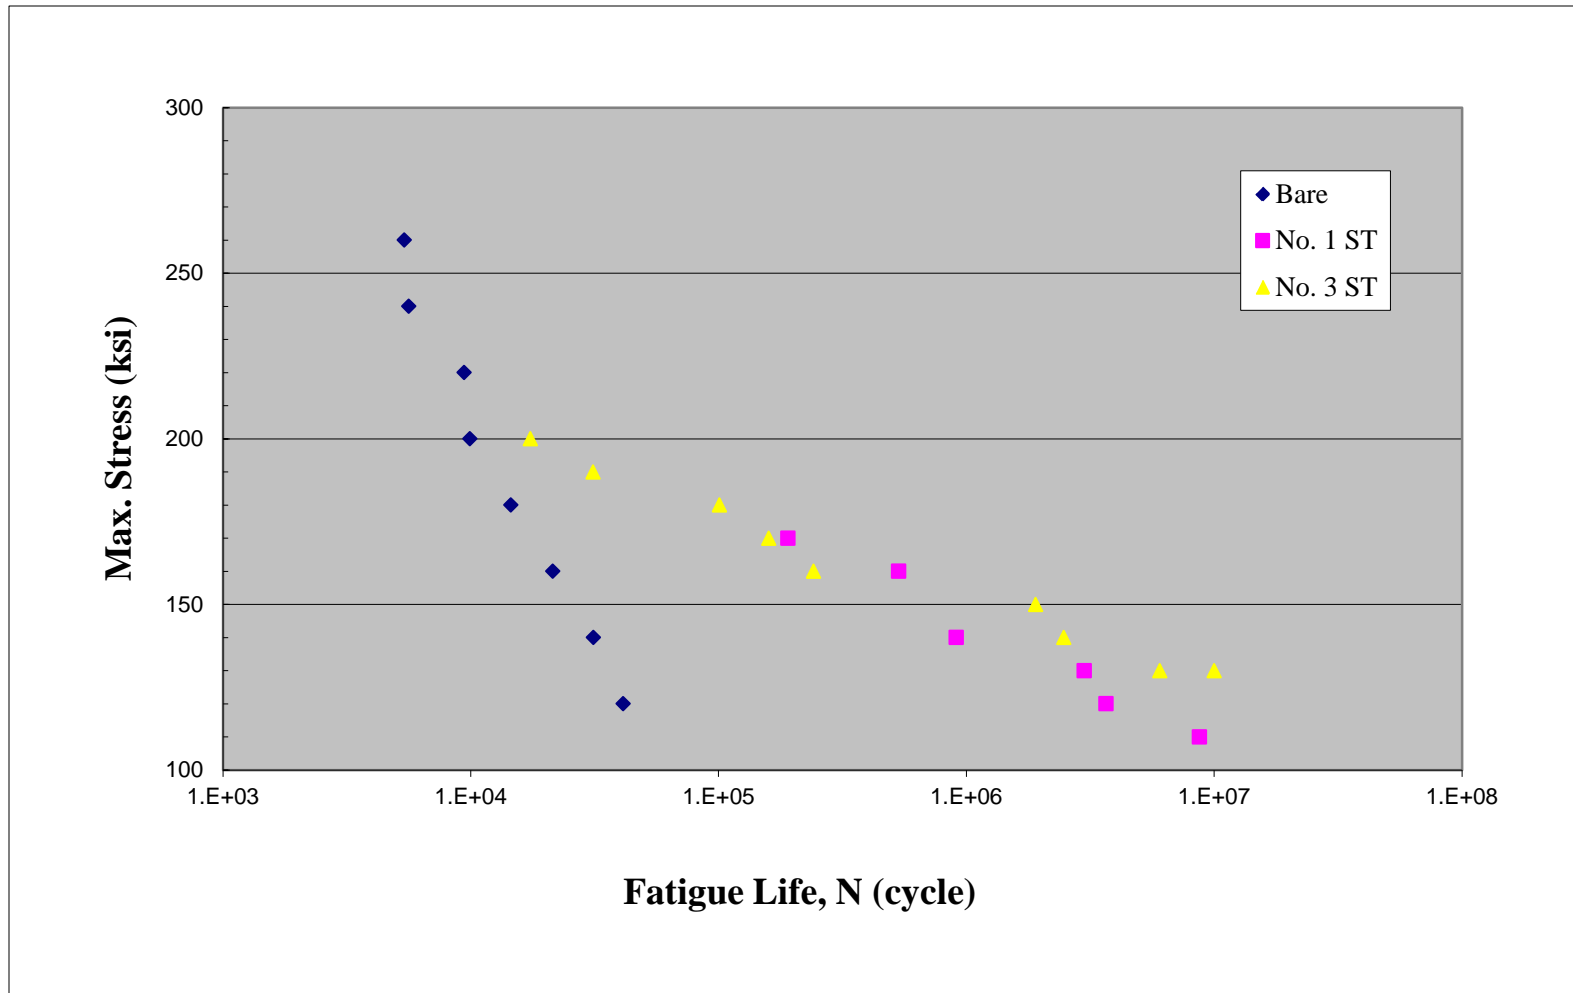
Figure 10: Stress-Life Fatigue Curves for Bare and Surface-Treated 4340 Steel Tested in 3.5% NaCl Solution

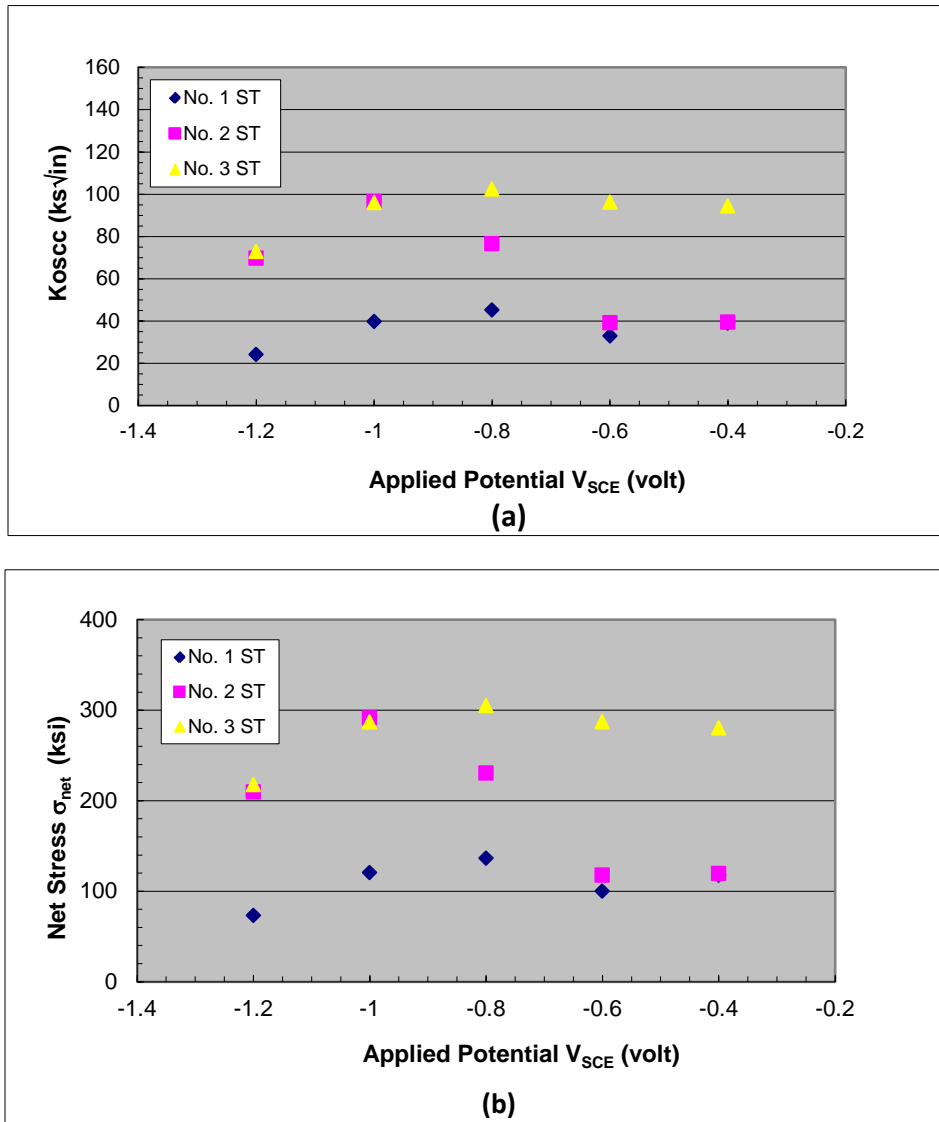
Figure 11: Variation of Threshold Stress Intensity for SCC  $K_{OSCC}$  and Net Stress  $\sigma_{net}$  with Applied Potential  $V_{SCE}$  (\* ST: Surface Treatment)

The variation of threshold stress intensity for SCC,  $K_{OSCC}$ , and net stress,  $\sigma_{net}$ , with applied potential,  $V_{SCE}$ , is shown in Figures A-11(a) and (b), respectively. These figures show that:

- The SCC resistance is greatest with the full coating system, intermediate for electroplated cadmium with chromate primer, and lowest for electroplated cadmium throughout the applied potentials, ranging from -1.2 to -0.4 V.

It is observable that each additional coating or an additional layer of coating results in a greater SCC resistance, Figure A-11. Consequently, electroplated and passivated cadmium provides the least SCC resistance, an additional primer coating an intermediate resistance, and final additional polyurethane coating the greatest SCC resistance in 3.5% NaCl solution. This may be attributed to an additional isolation and protection by an additional layer of coating against the corrosive medium, 3.5% NaCl solution.

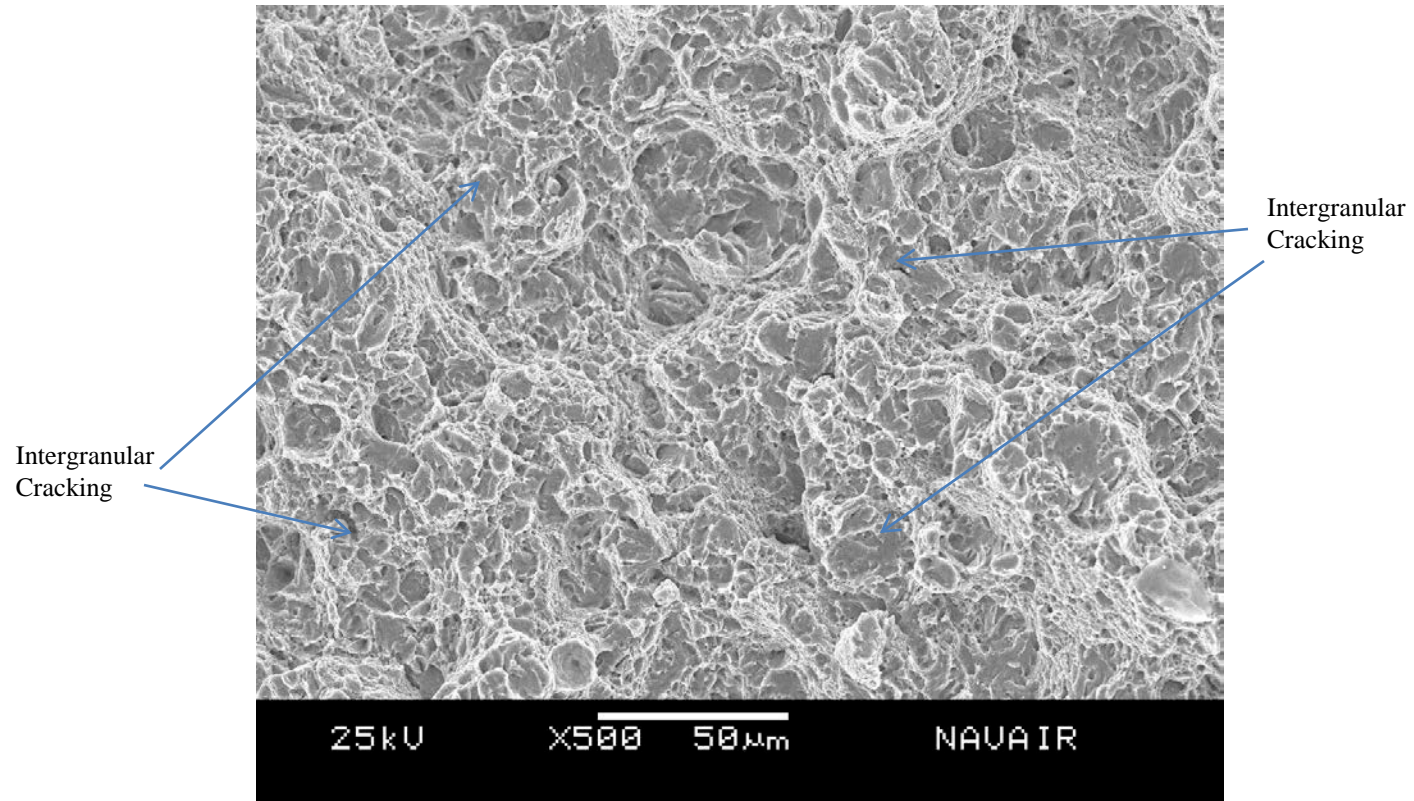
Figure 12: SEM Fractograph of No. 2 Surface-Treated Specimen, Fractured under Four-Point Bending in Air

A typical SEM fractograph for the No. 2 coating system, followed by four-point bending fracture in air, shows mostly dimples of various sizes and scattered intergranular facets, some with secondary cracks along grain boundaries, Figure A-12.

The bending strengths of the coated specimens are lower than that of bare specimens in air. In addition, the fractograph of No. 2 coating system specimen (Figure A-12), which was fractured under four-point bending in air, shows scattered intergranular facets. This reduction in bending strength is similar to that in the fatigue strength of the surface-treated specimen in air, Figure 9. Therefore, it is deducible that the reduction in bending strength and intergranular cracking are also attributed to the hydrogen embrittlement, induced during electroplating the cadmium, a part of the No. 2 coating system.

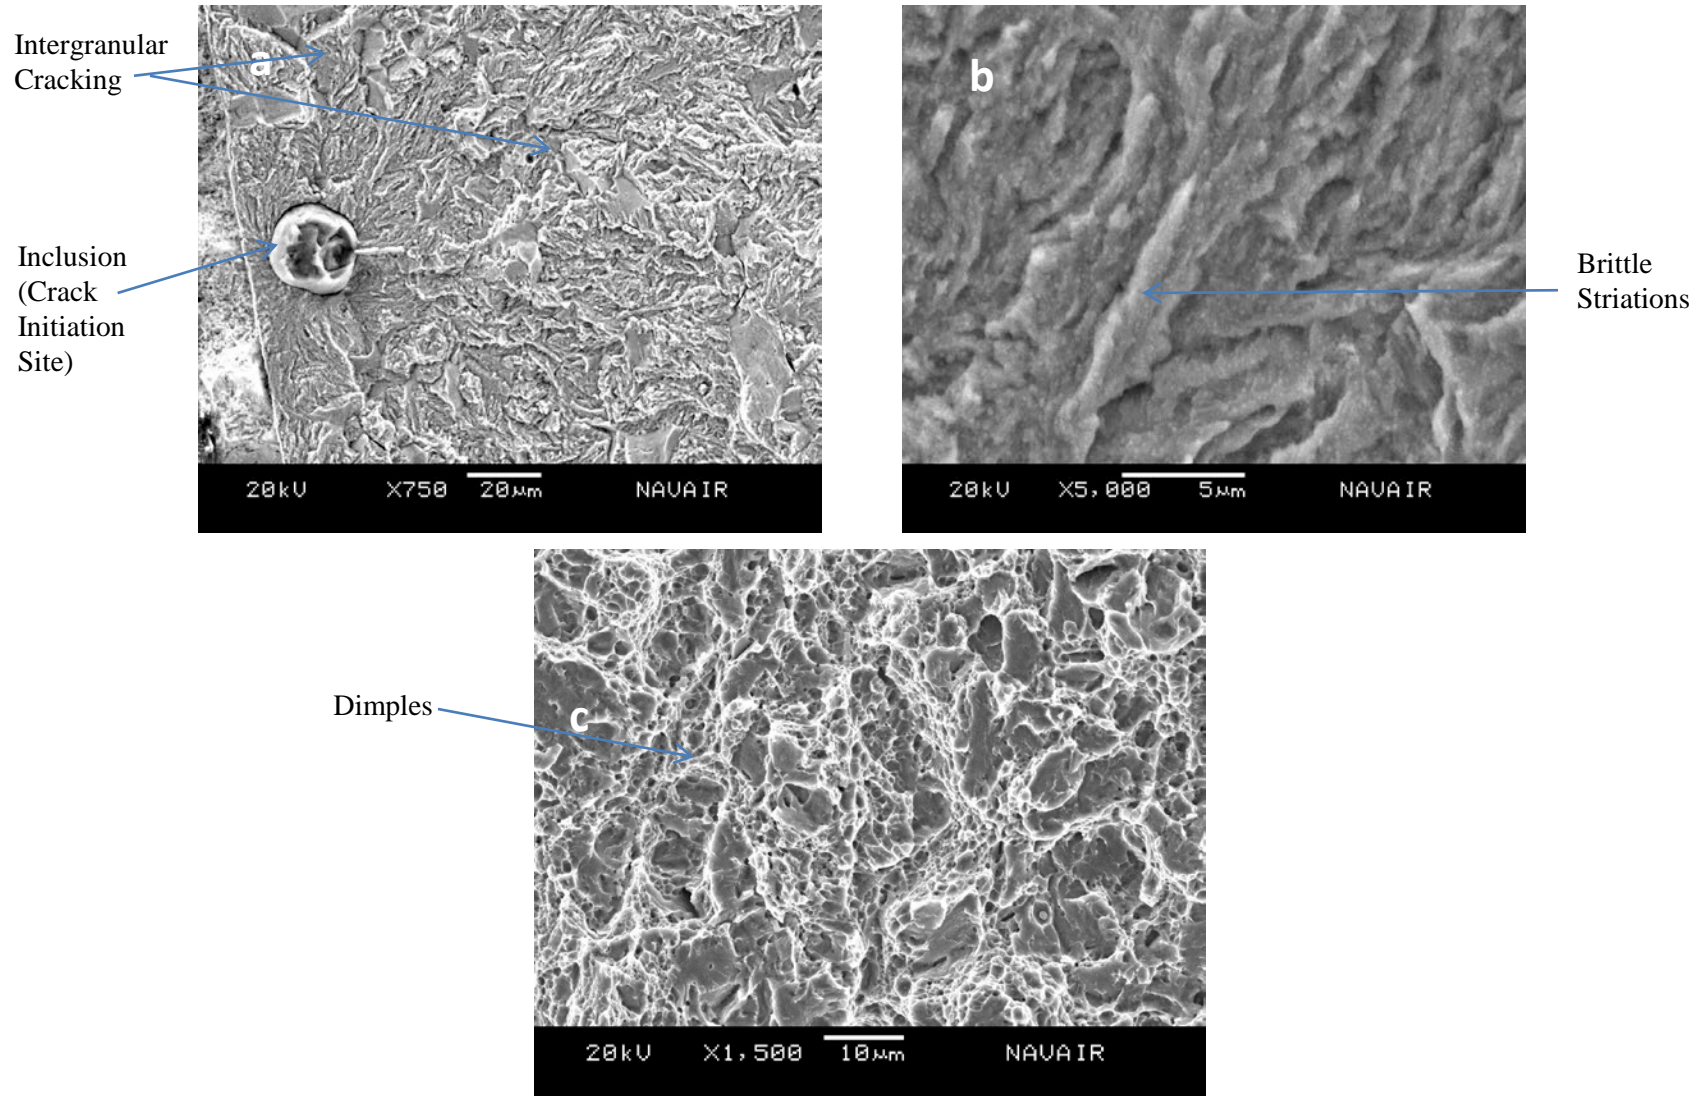
Figure 13: SEM Fractographs of No. 3 Surface-Treated Specimen, Fatigue-Tested in Air

Typical SEM fractographs for the No. 3 coating system, fatigue-tested in air and 3.5% NaCl solution, are shown in Figures A-13 and A-14, respectively. These figures indicate that:

- The fatigue crack was initiated at an inclusion at or near the surface of the base-metal in air and 3.5% NaCl solution, Figures A-13(a) and A-14(a).
- In the early stage of fatigue crack growth, scattered intergranular cracking occurred near the fatigue crack initiation site in air and 3.5% NaCl solution. This is evidenced by intergranularly separated smooth grain facets and secondary cracks at the grain boundaries in scattered spots, Figures A-13(a) and A-14(a).

- Within the slow crack growth area, faint and poorly defined striations or striations-like features were formed in air, Figure A-13(b). On the other hand, intergranular cracking and formation of brittle striations occurred in 3.5% NaCl solution. This is evidenced by intergranularly separated grain facets, secondary cracks at grain boundaries and brittle striations on the fracture surface, Figure A-14(b).

- In the overload fracture area, microvoid coalescence occurred in air and 3.5% NaCl solution. This is evidenced by the dimples of various sizes, covering the entire fracture surface, Figures A-13(c) and A-14(c).

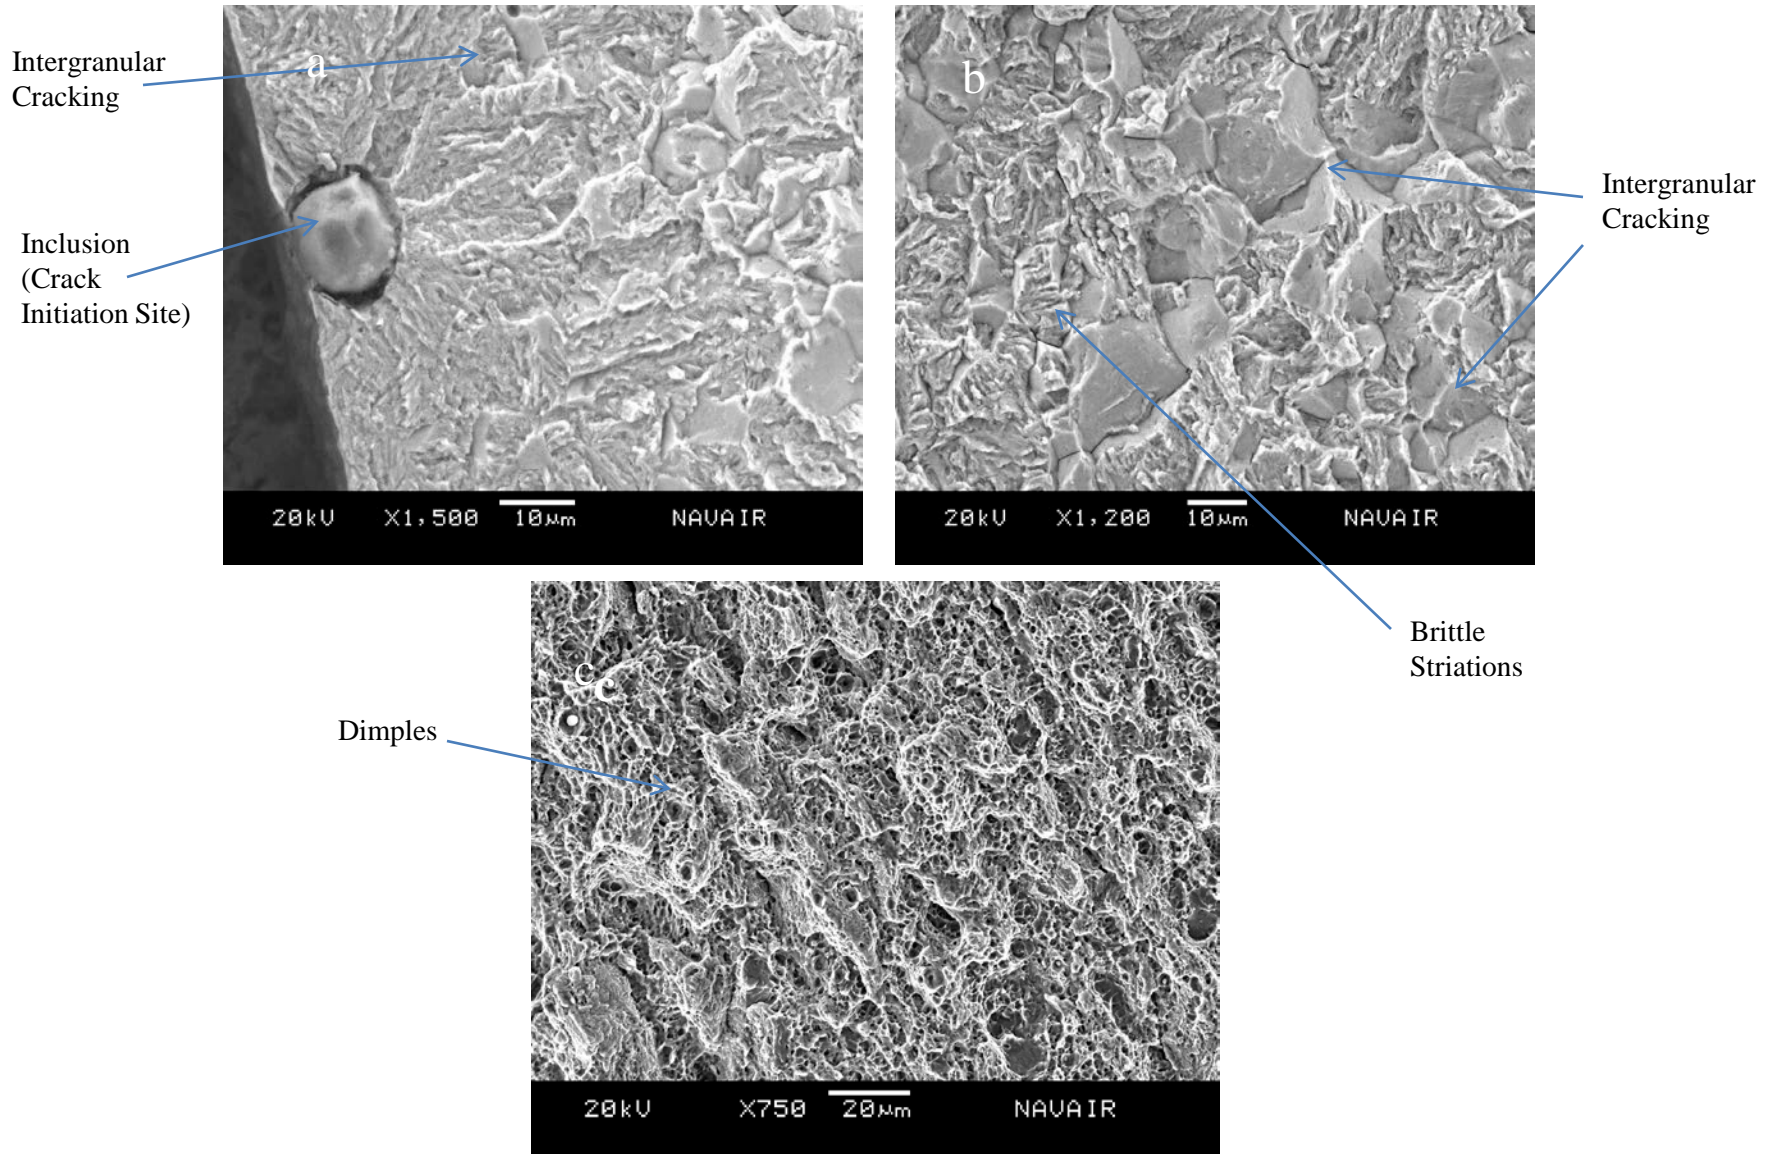
Figure 14: SEM Fractographs of No. 3 Surface-Treated Specimen, Fatigue-Tested in 3.5% NaCl Solution

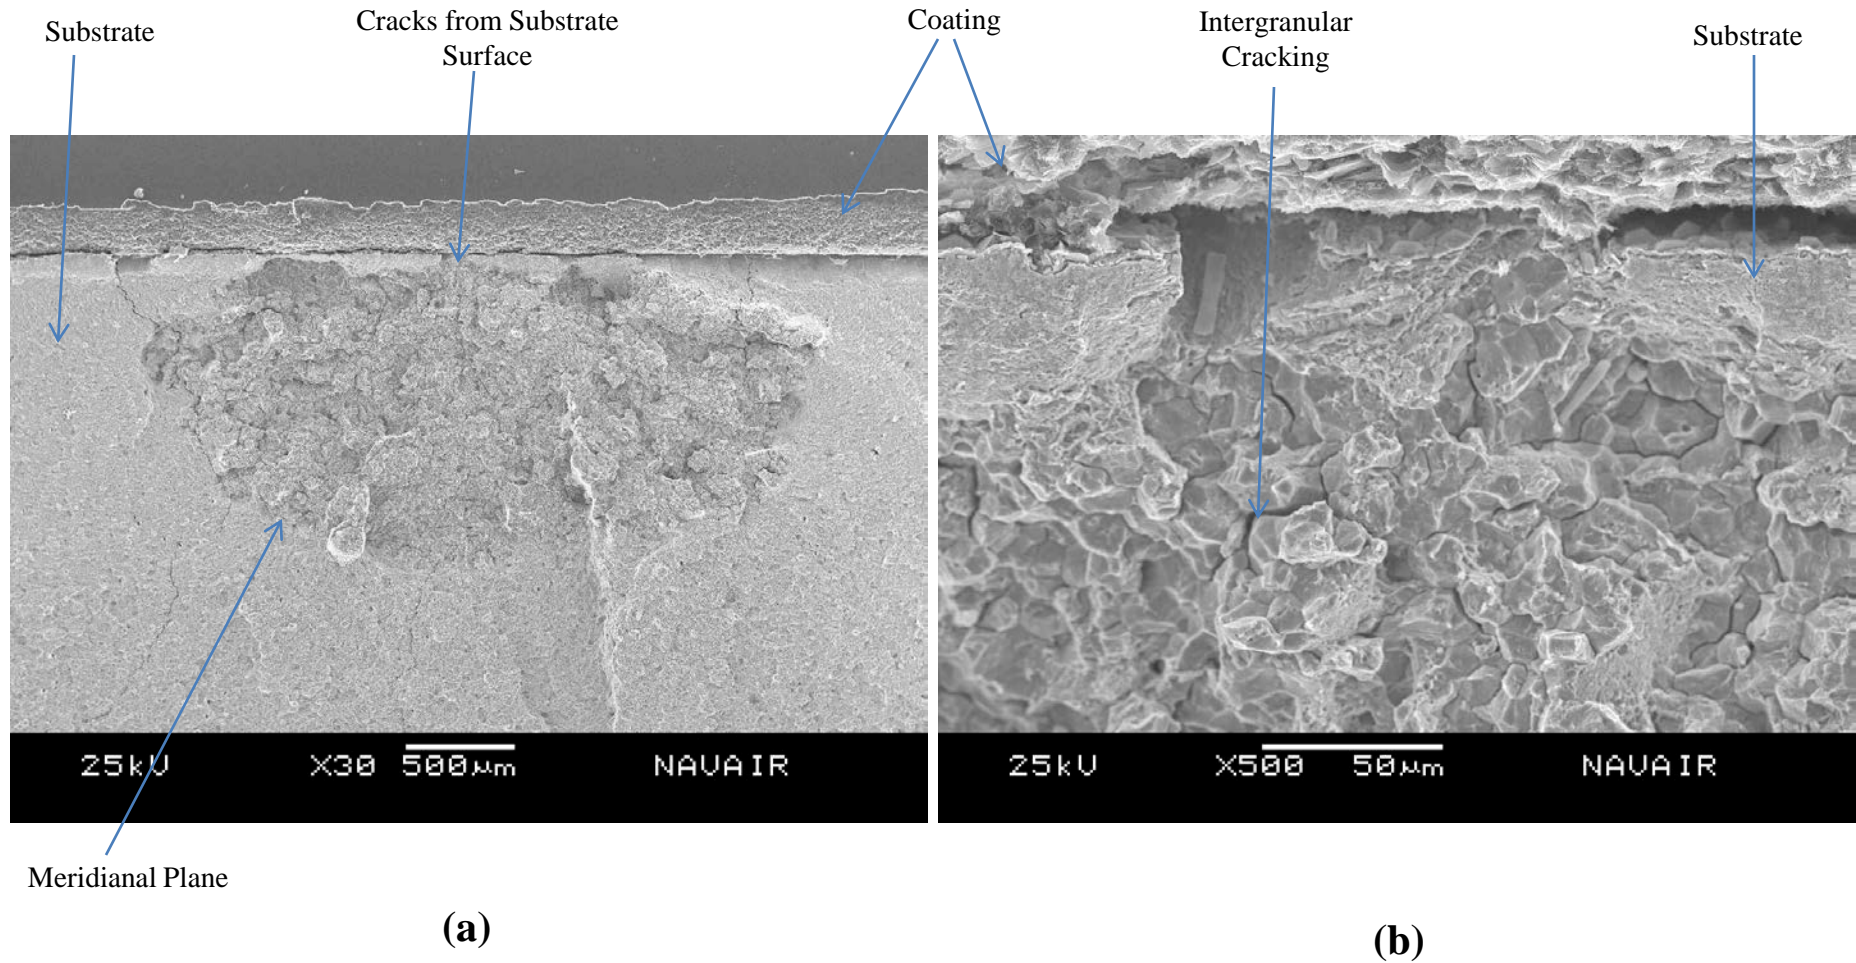
Figure 15: SEM Fractographs of No. 3 Surface-Treated Specimen, RSL-SCC Tested at  $V_{SCE} = -1.2$  V in 3.5% NaCl Solution

Typical fractographs for the No. 3 coating system, followed by RSL-SCC test at  $V_{SCE} = -1.2$  V in 3.5% NaCl solution, are illustrated in Figure A-15. Figure A-15(a) shows the coating, partly separated from the substrate, several roughly parallel cracks, initiated from the substrate-surface and grown into the substrate, and a subsurface cracking zone of meridional plane-shape below the notch-tip. It is believed that 3.5% NaCl solution seeped through the parallel cracks into the subsurface cracking zone during the SCC test. The subsurface cracking zone is occupied by intergranular facets and secondary cracks along grain boundaries, Figure 15(b).

- A cracking zone of meridional plane-shape was formed below the notch-tip of a square bar specimen, which was subjected to four-point bending at  $V_{SCE} = -1.2$  V in a 3.5% NaCl solution, Figure 15(a).
- The cracking zone was occupied by intergranular facets, Figure 15(b).

This observation evidences the initiation and propagation of intergranular SCC in a subsurface zone of meridional plane-shape. Such a zone has been known to be formed by a Hertz line of constant maximum shear stress under a frictionless load from a rigid sphere (reference 22).
